Monster DNA Wire Replacement

One or both of the speakers on the Monster DNA headphones is not working. The problem could be the wiring on the speaker part.

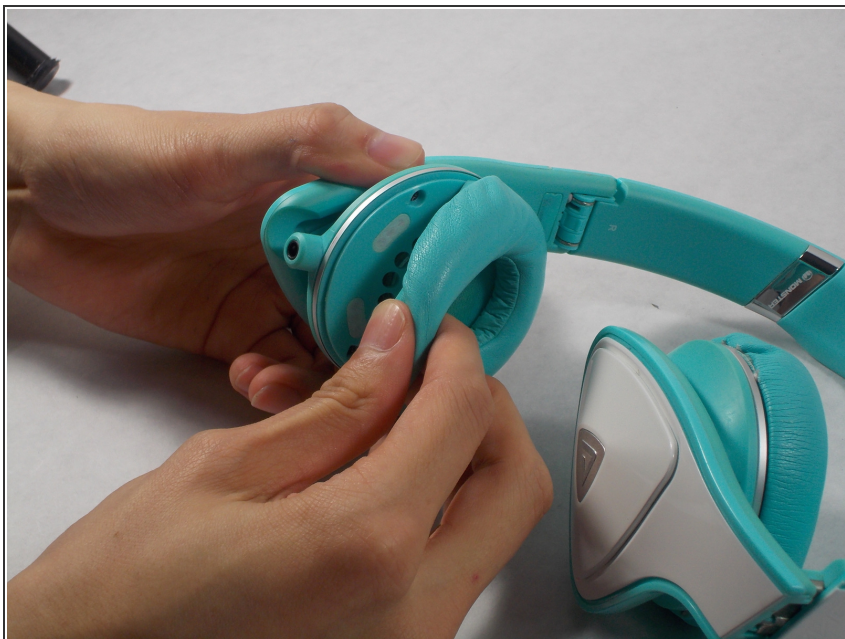
Step 1 — Wire

- Take off the ear cushions by pulling on the sides.

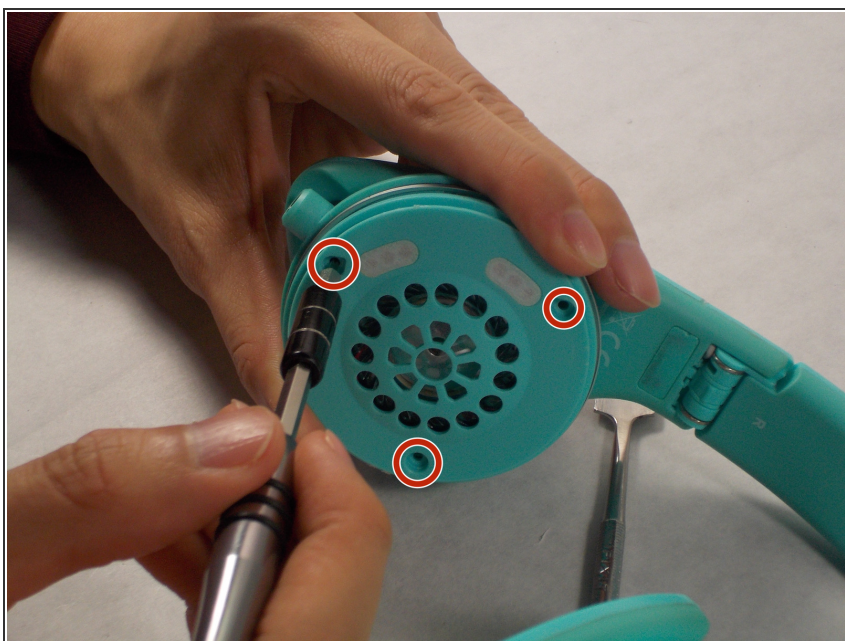
Step 2

- Use a Phillips #2 screwdriver to unscrew the three 5mm screws that secure the speaker cover.

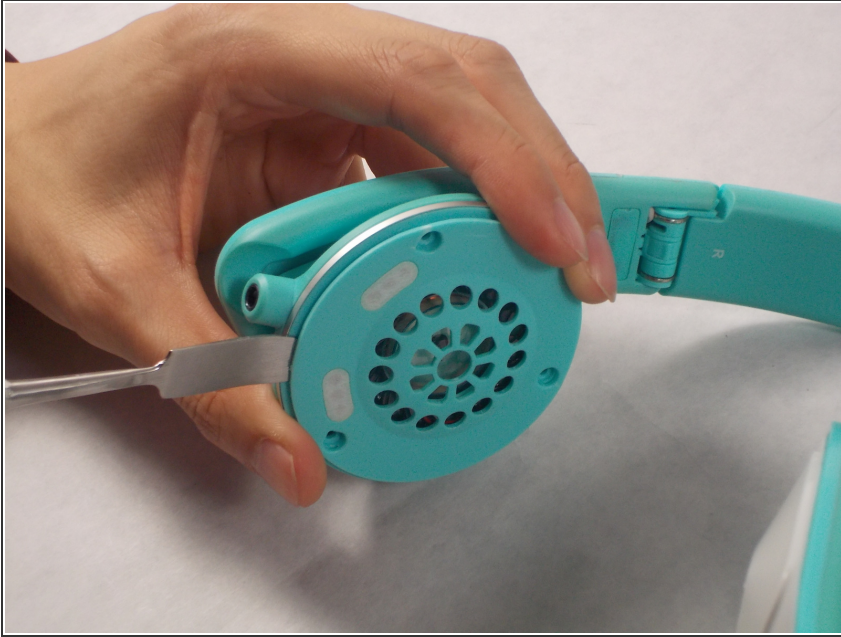
Step 3

- Use a plastic opening tool or a metal spudger to pry off the plate
- ⚠ Be careful as too much force may cause damage to your headphones.

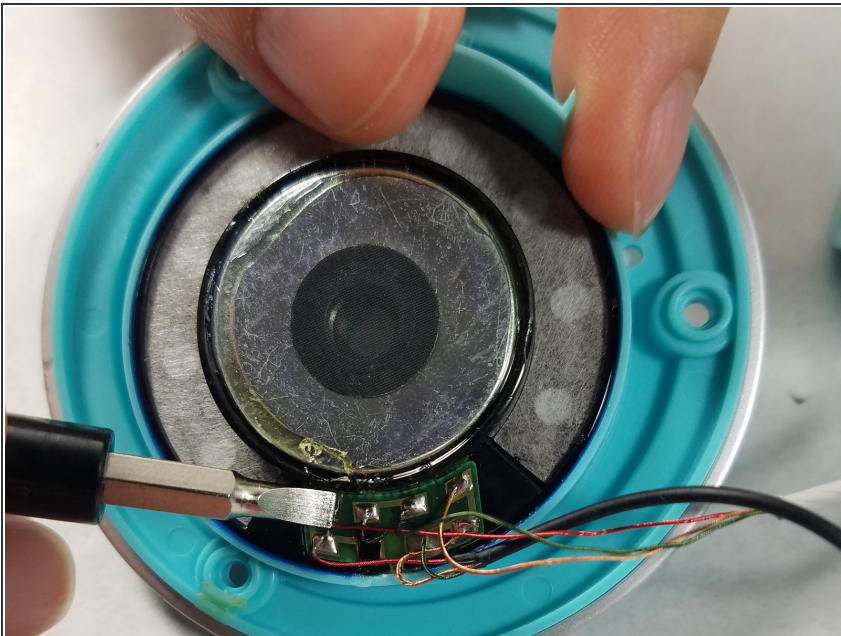
Step 4

- Once the loose wire or wires are located on the back of the speaker, use a soldering iron to attach the loose wire back onto the speaker.

To reassemble your device, follow these instructions in reverse order.
